Manhole Inspection Summary

Manhole # S43CC_015MH

Insp Date: **12/18/07 3:47 PM**

Location Address: **ashland-madison housing**

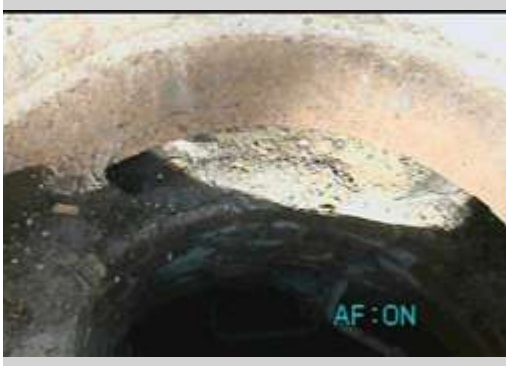
Defect 3

Offset: **3** (in.)

frame offset

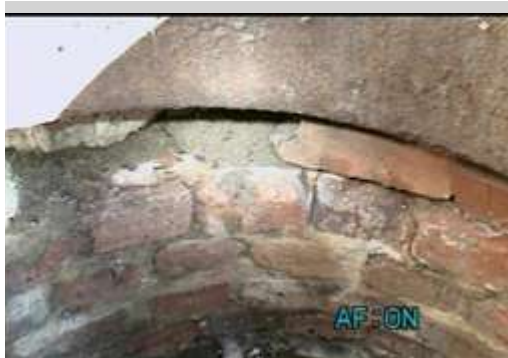
Defect 2

Condition: ☐ Sound ☐ Cracked ☐ Root Intrusion ☒ **Loose Brick** ☐ Deteriorated

corbel loose bricks

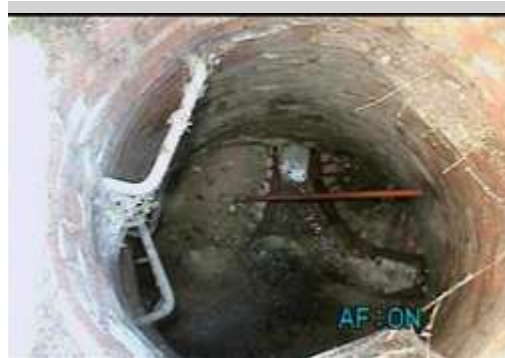
Defect 1

Condition: ☐ Sound ☐ Cracked ☐ Root Intrusion ☐ Deteriorated ☐ Leaks ☒ **Debris**

Bench & channel debris

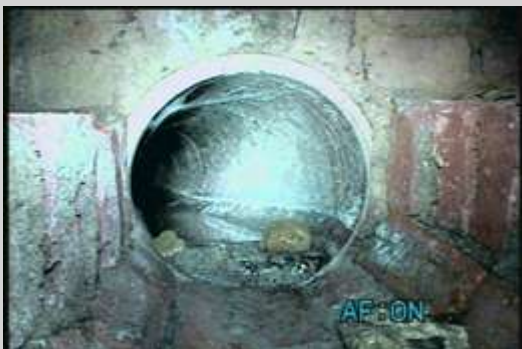
3 O'Clock Inflow

Deposits: ☐ None ☐ Mud ☒ **Sludge** ☐ **Debris** ☐ Grease

Silt Depth: 1.5 (in.) Deposits Extent: **Medium**

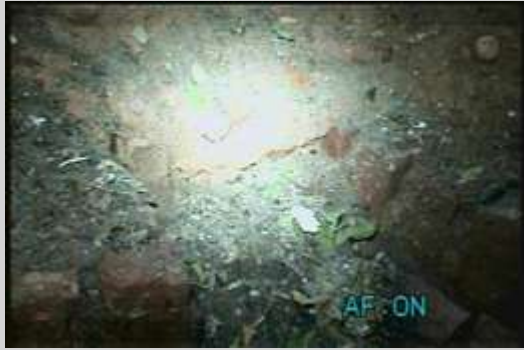
8 O'Clock Inflow

clear view of pipe connection blocked by
channel debris

Deposits: ☐ None ☐ Mud ☐ Sludge ☒ **Debris** ☐ Grease

Silt Depth: **8** (in.) Deposits Extent: **Heavy**
